**Skamania PUD – Carson Water  
Treatment Plant Upgrade**

Project Manual, Volume 3 of 4

# **Geotechnical Data Report**

Carson Water Treatment Plant  
Public Utility District Number 1 of Skamania County  
Carson, Skamania County, Washington

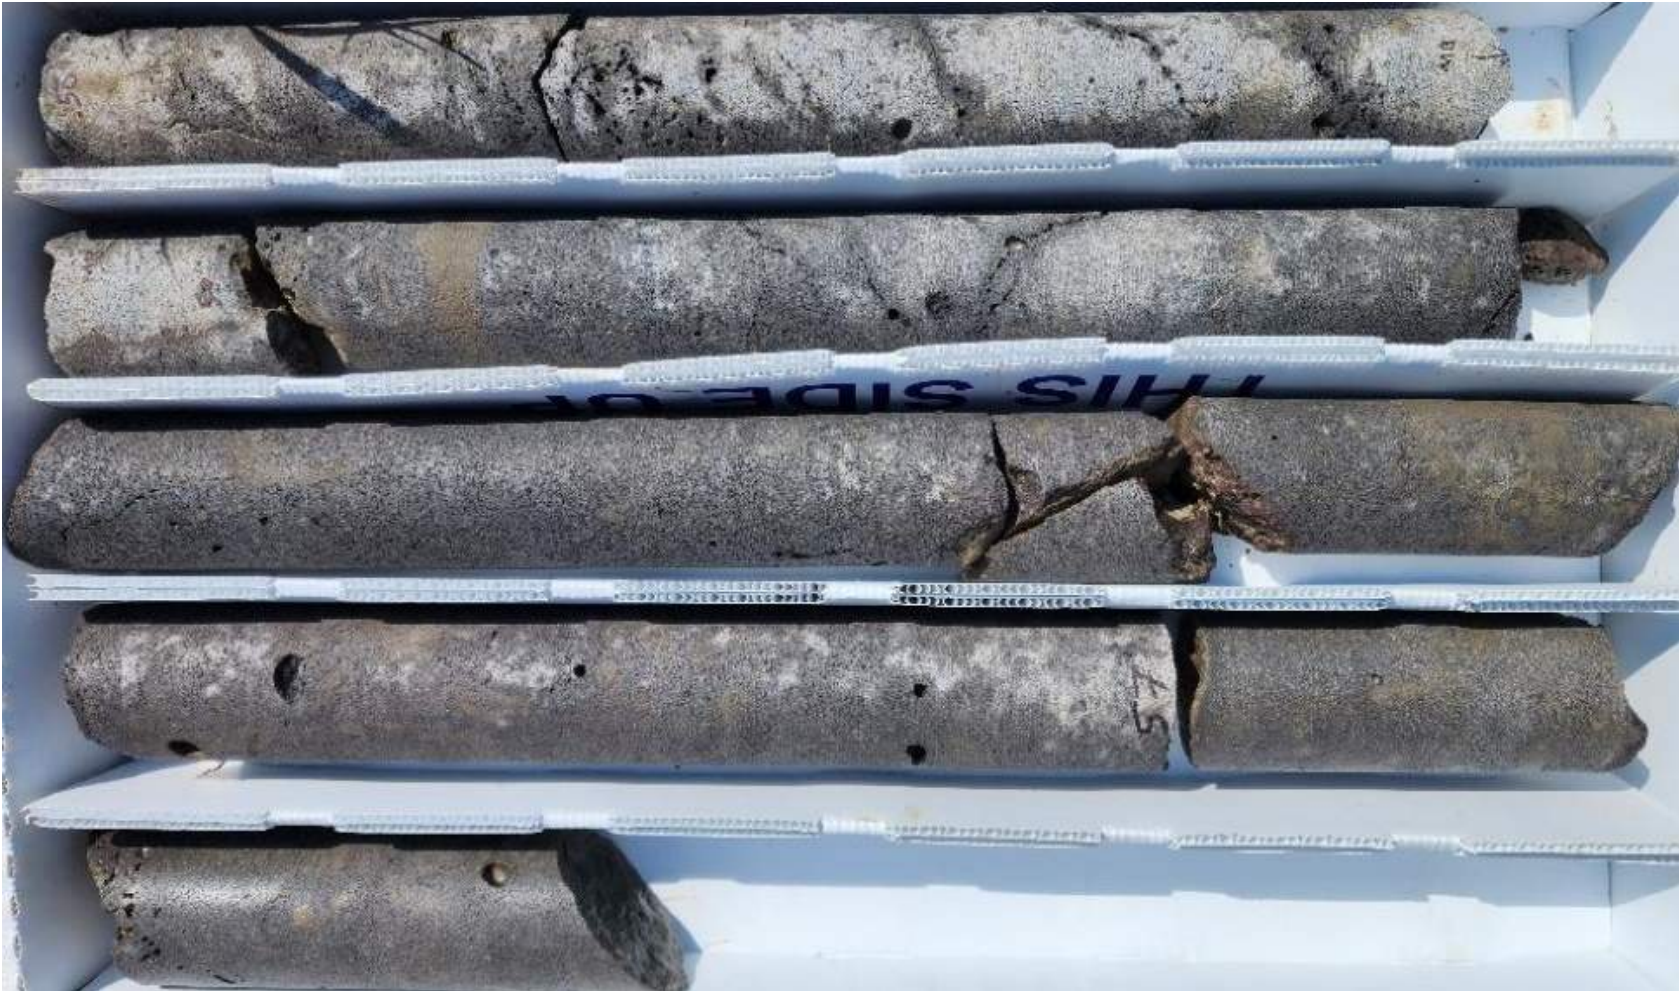
Core Photograph 1, Boring TB-01, Box 1, 50 to 57.5 feet

1. Core samples are arranged in each box with increasing depth from left to right and top to bottom.
2. HQ size boxes are each 24 inches in length.
3. Refer to test bore logs for additional core details and descriptions.

**Boring TB-01 (Double-Barrel Diamond-Bit HQ size; May 19, 2023)**

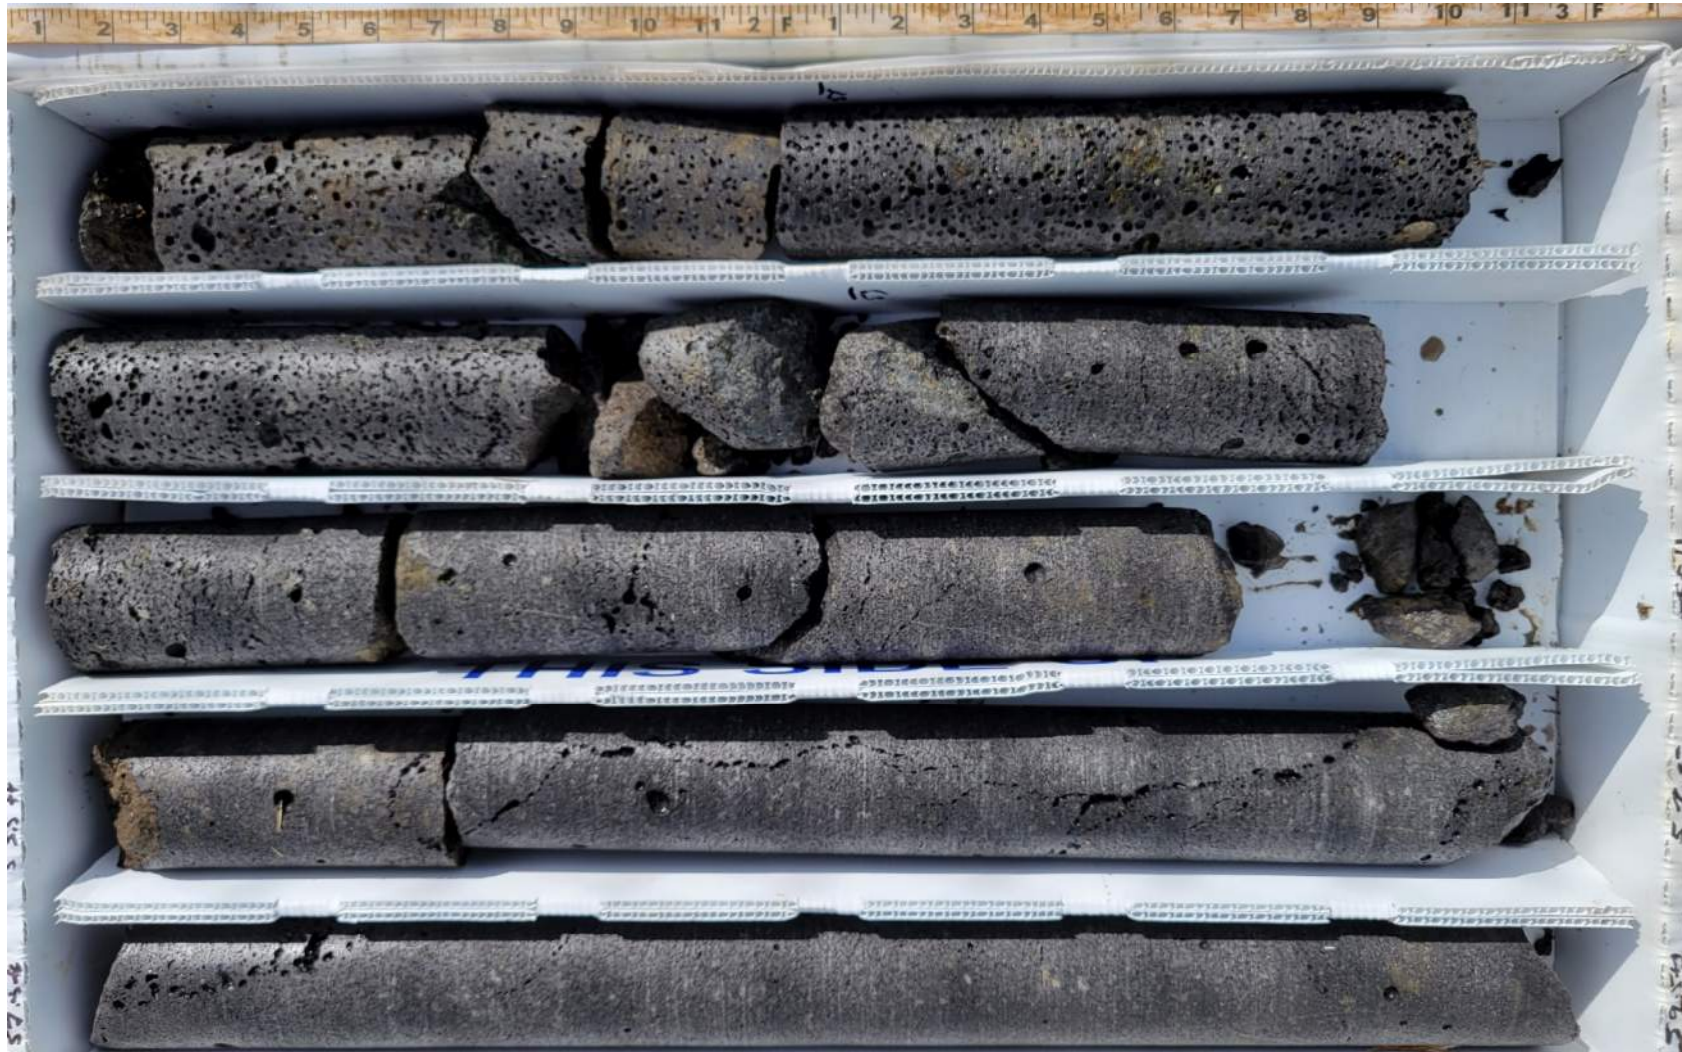
Core Photograph 9, Boring TB-06, Box 1, 50 to 59.5 feet

**Boring TB-06 (Double-Barrel Diamond-Bit HQ size; August 30, 2023)**
