Groundwater Contour  
Map (09/19/2017)

210 McKenzie  
RI/FS  
09/20/17

210 McKenzie Avenue  
Bellingham, WA 98225

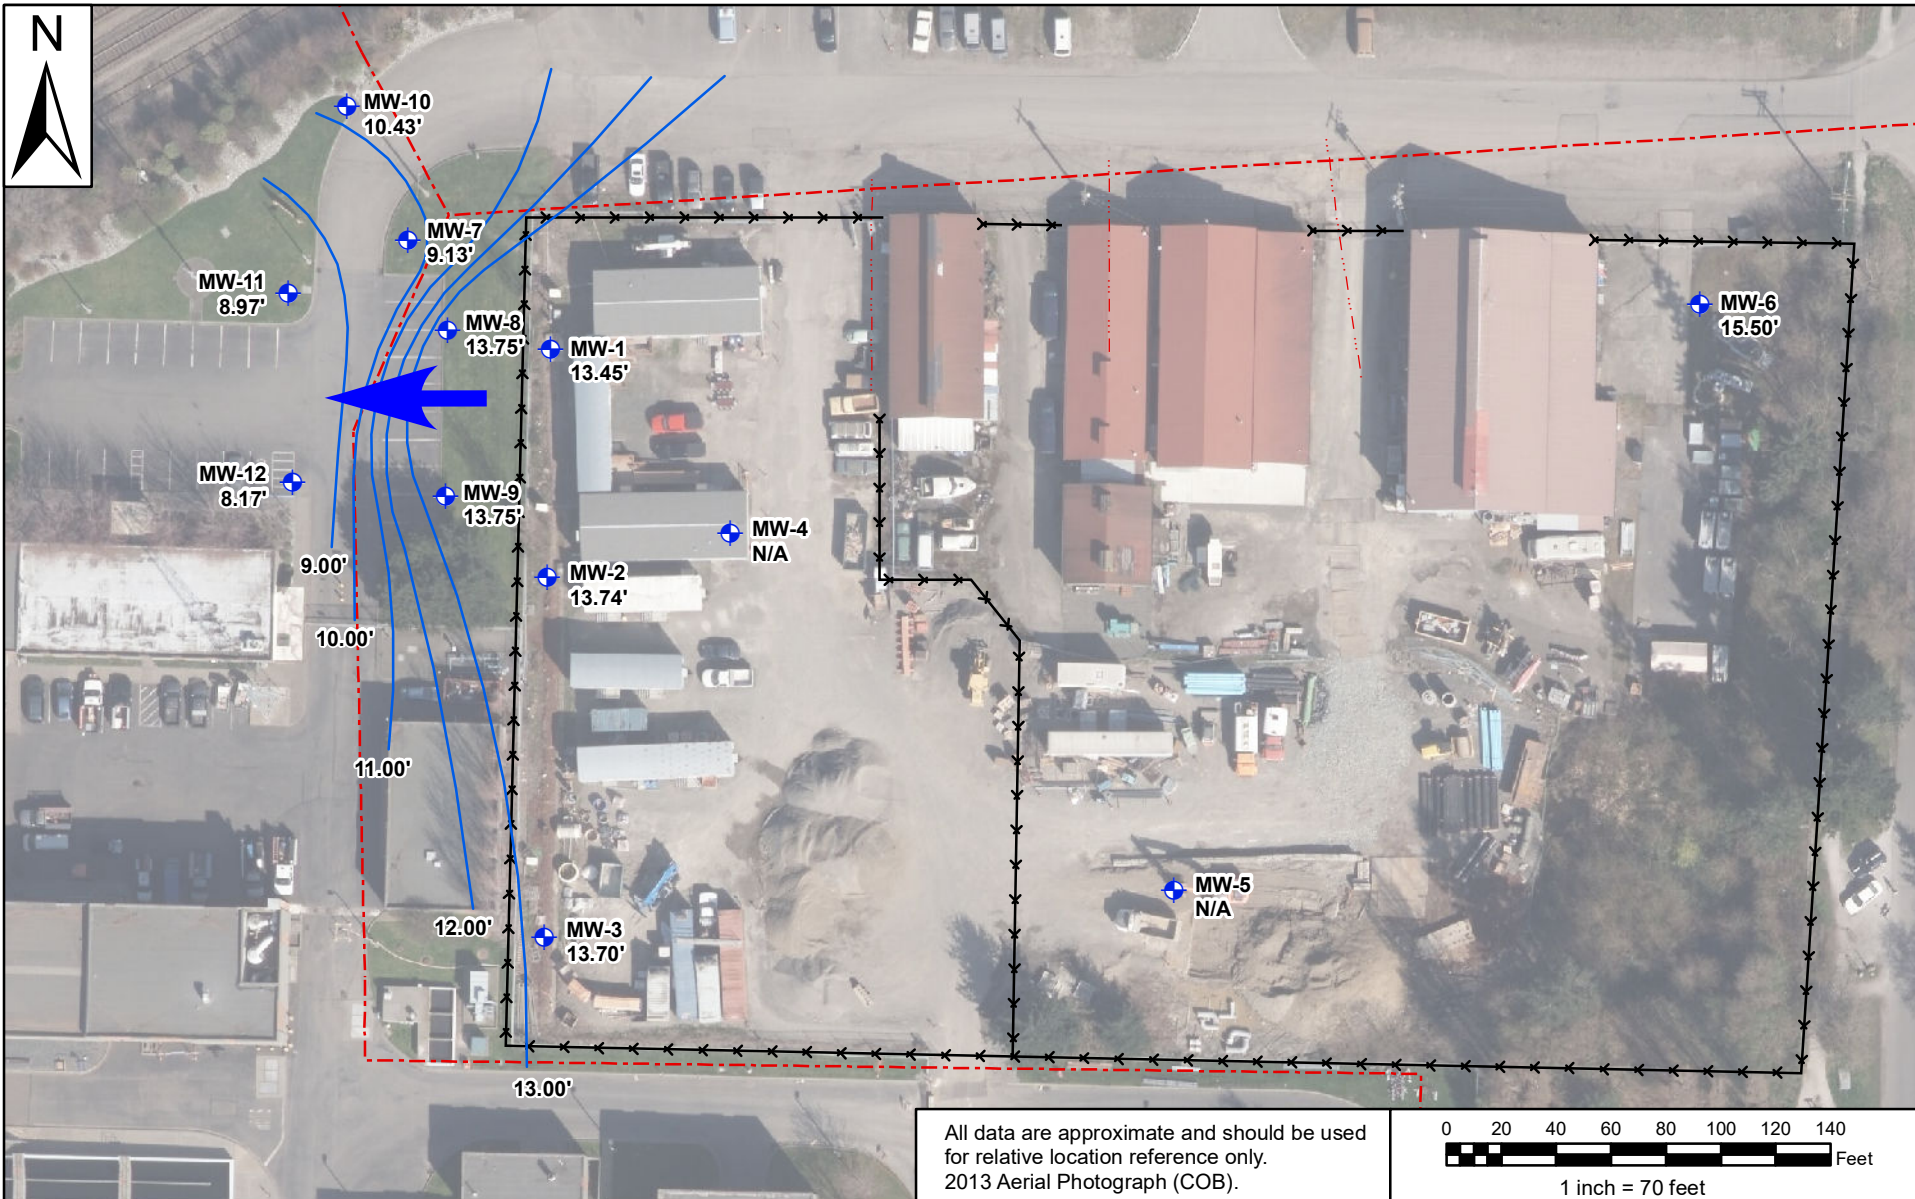
Figure G-24

Groundwater Contour  
Map (09/20/2018)

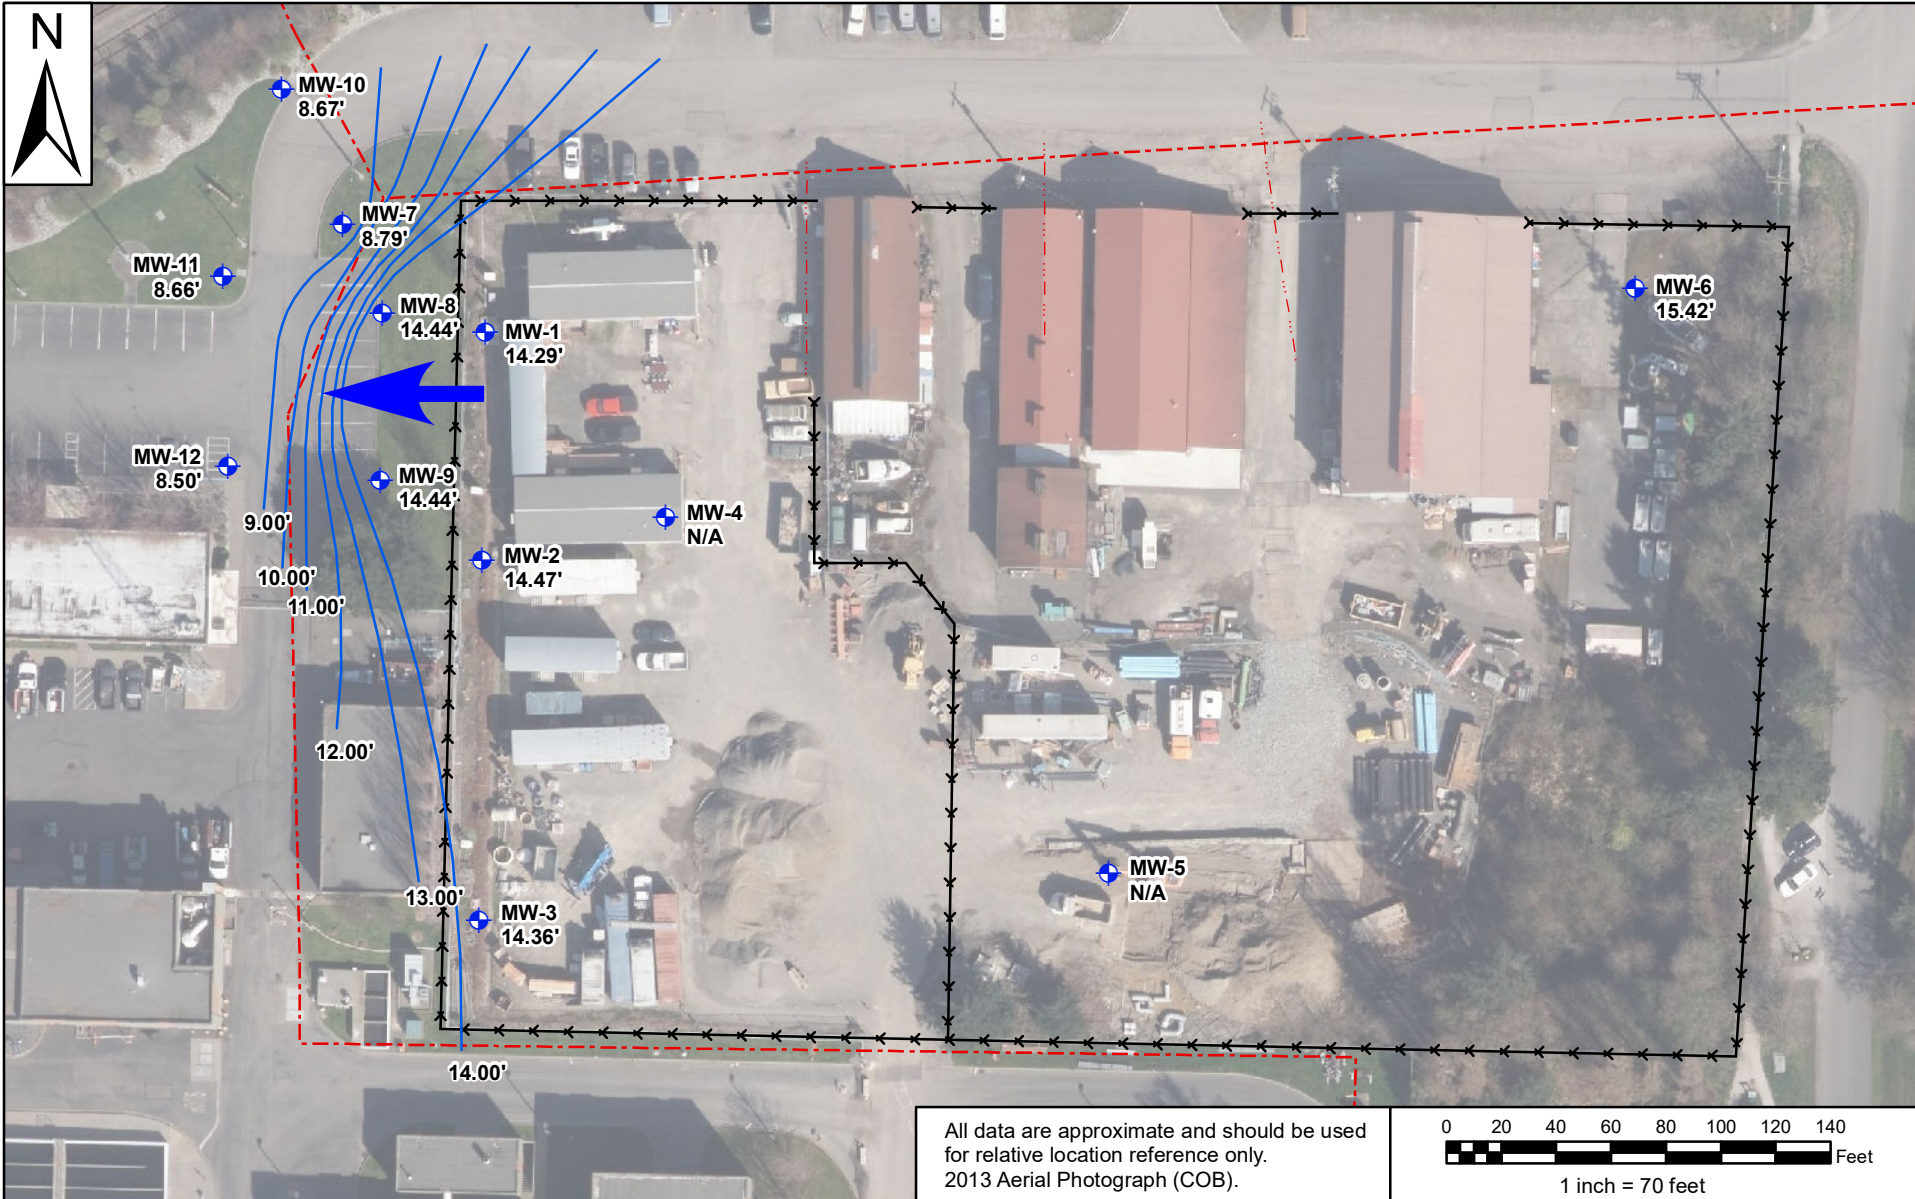
Figure G-25

Groundwater Contour  
Map (08/06/2019)

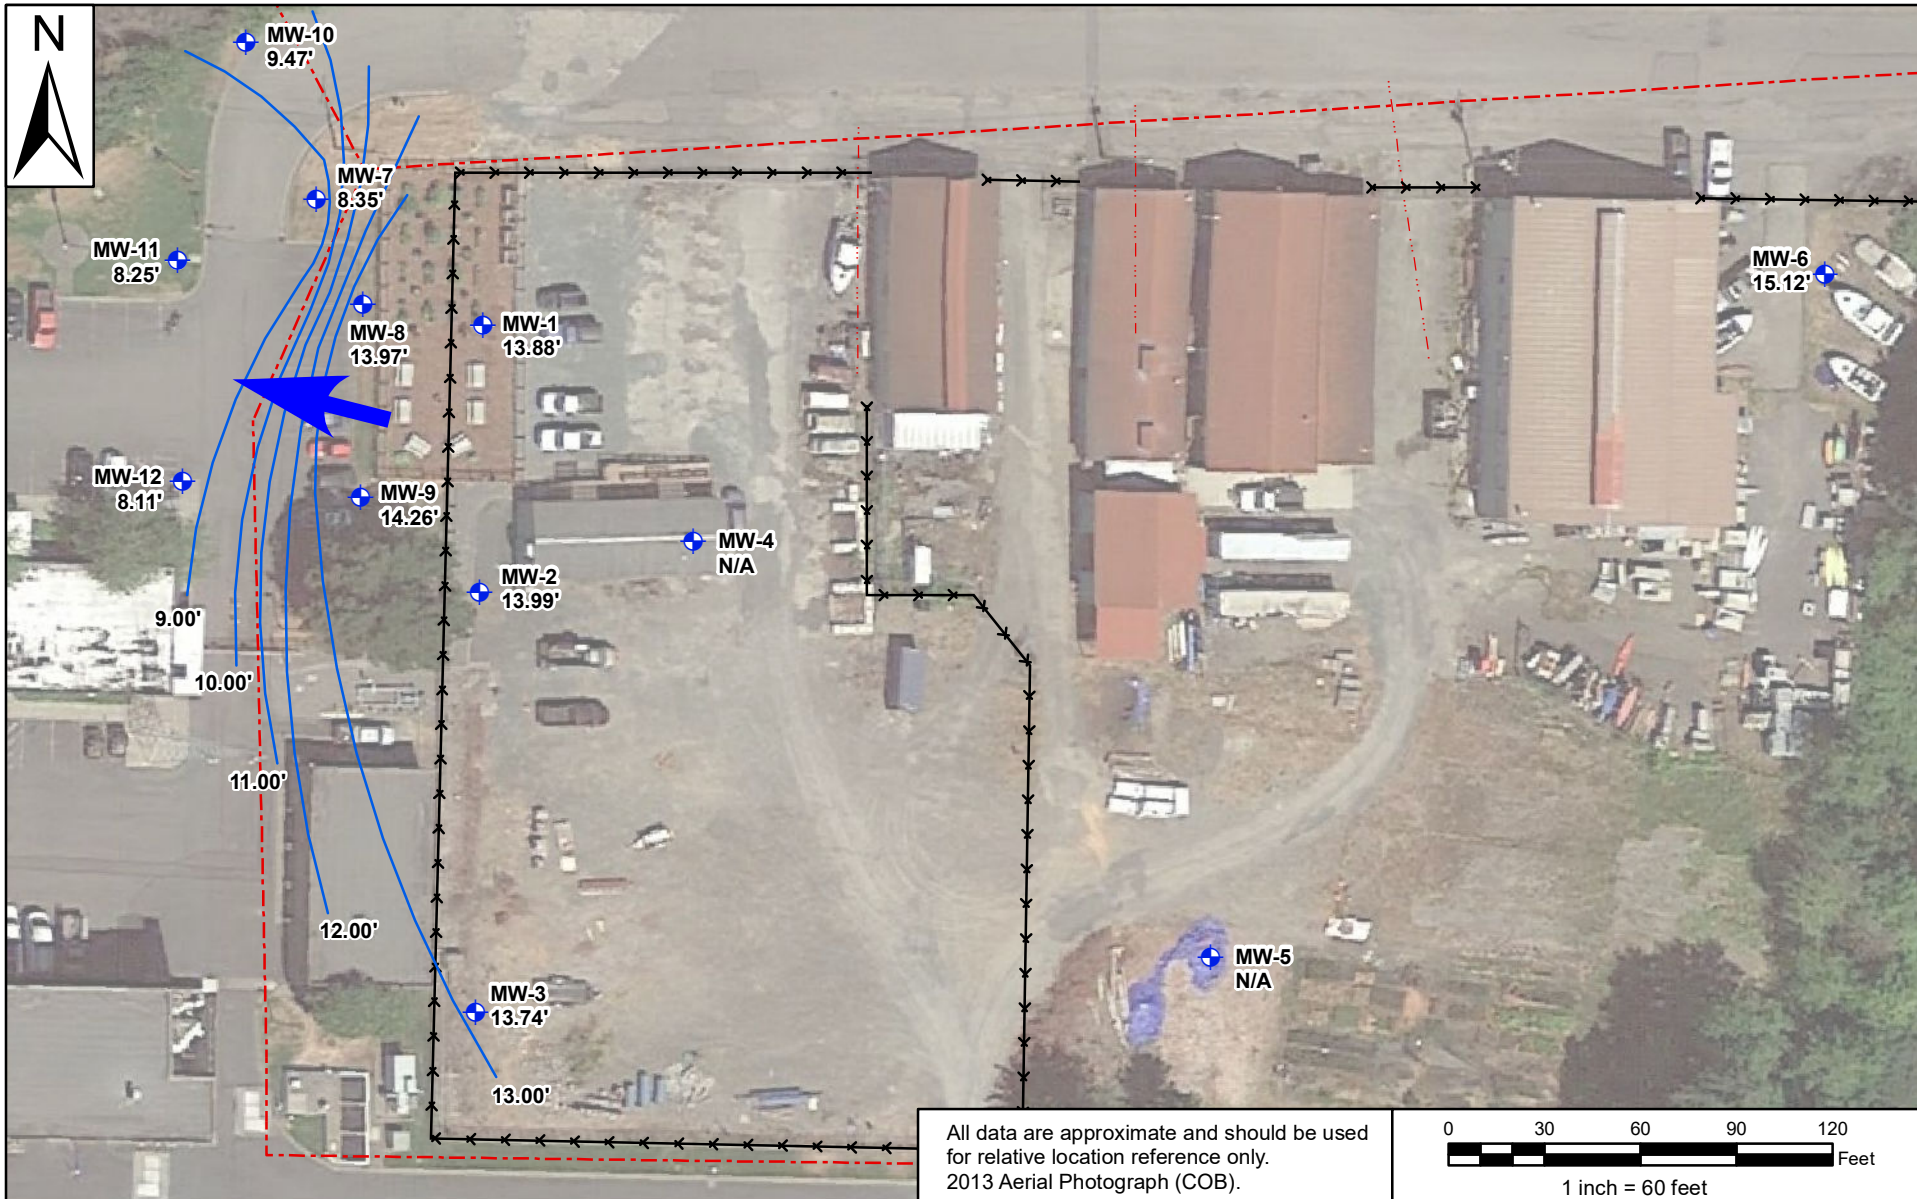
**Figure G-26**

Groundwater Contour  
Map (09/14/2020)

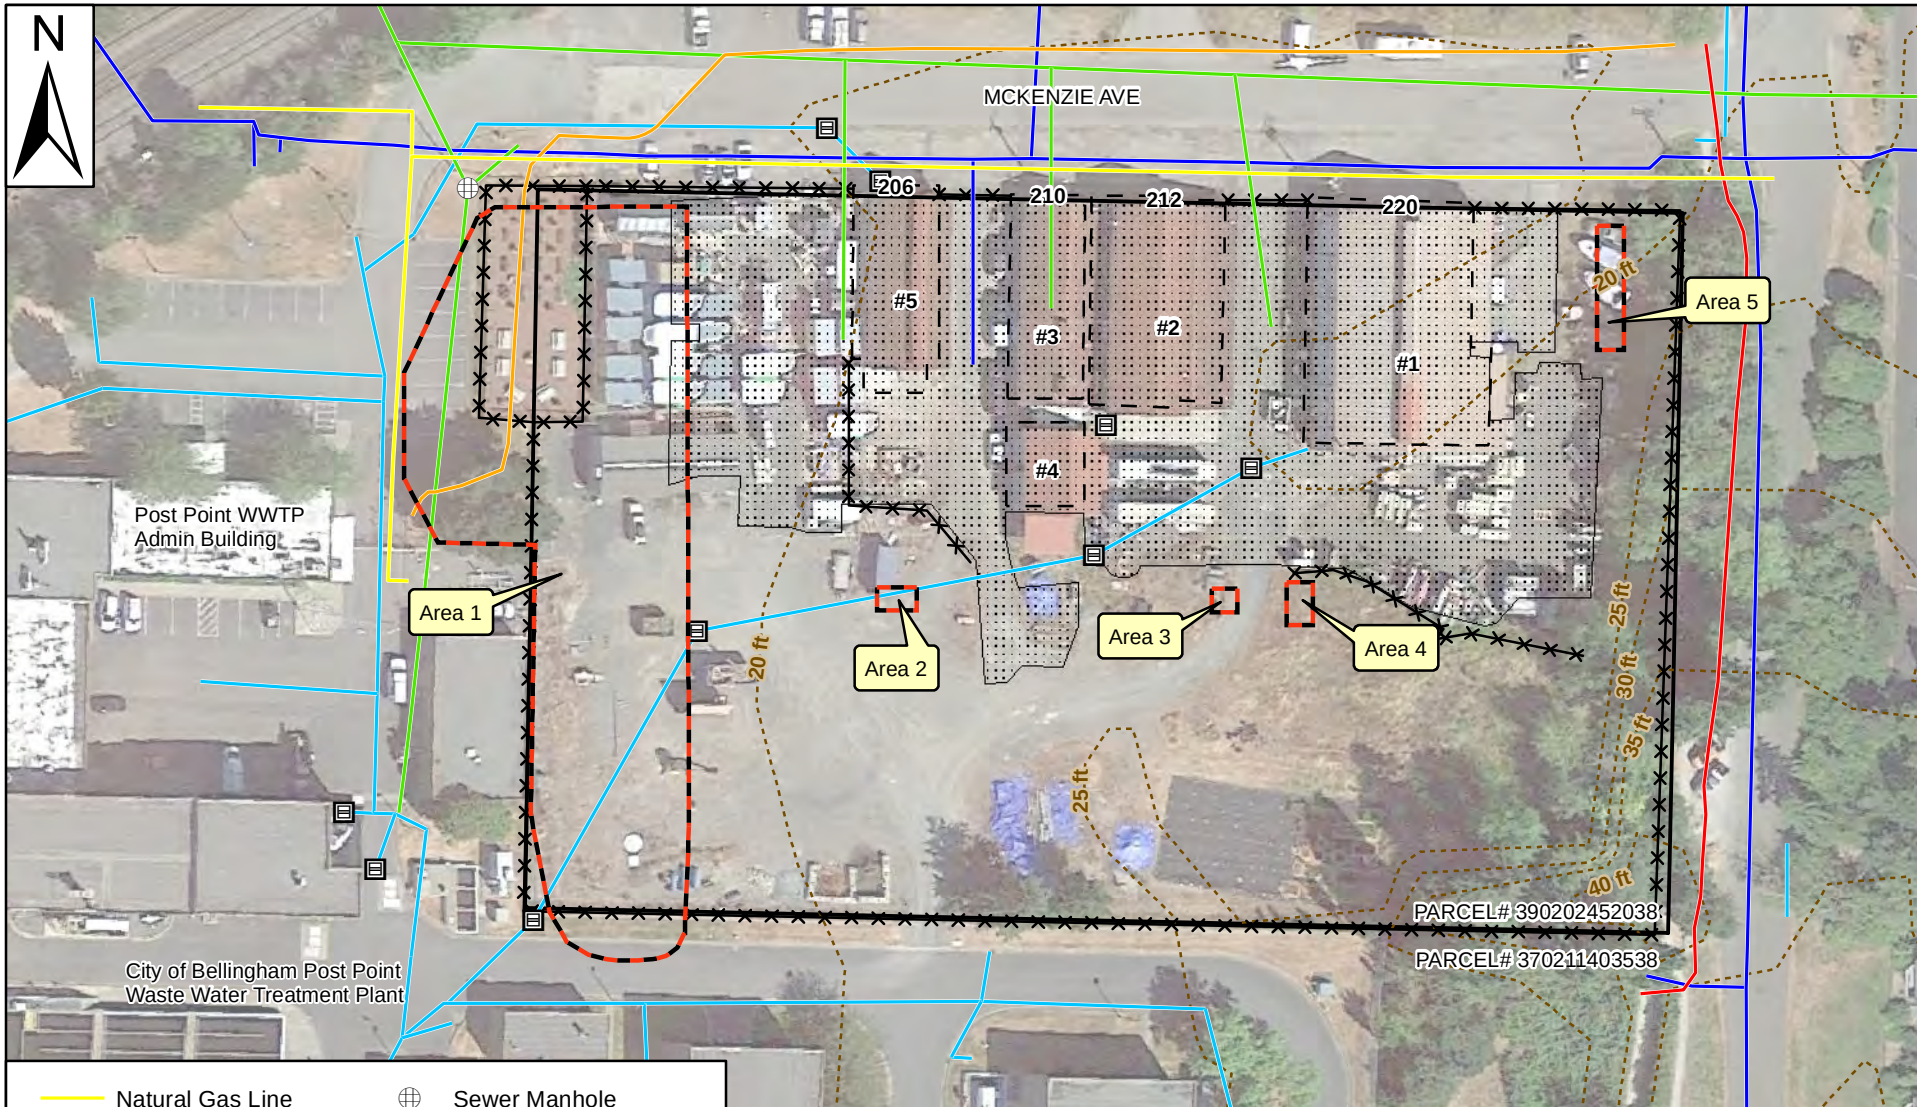
# Figure A-3

## Site Map

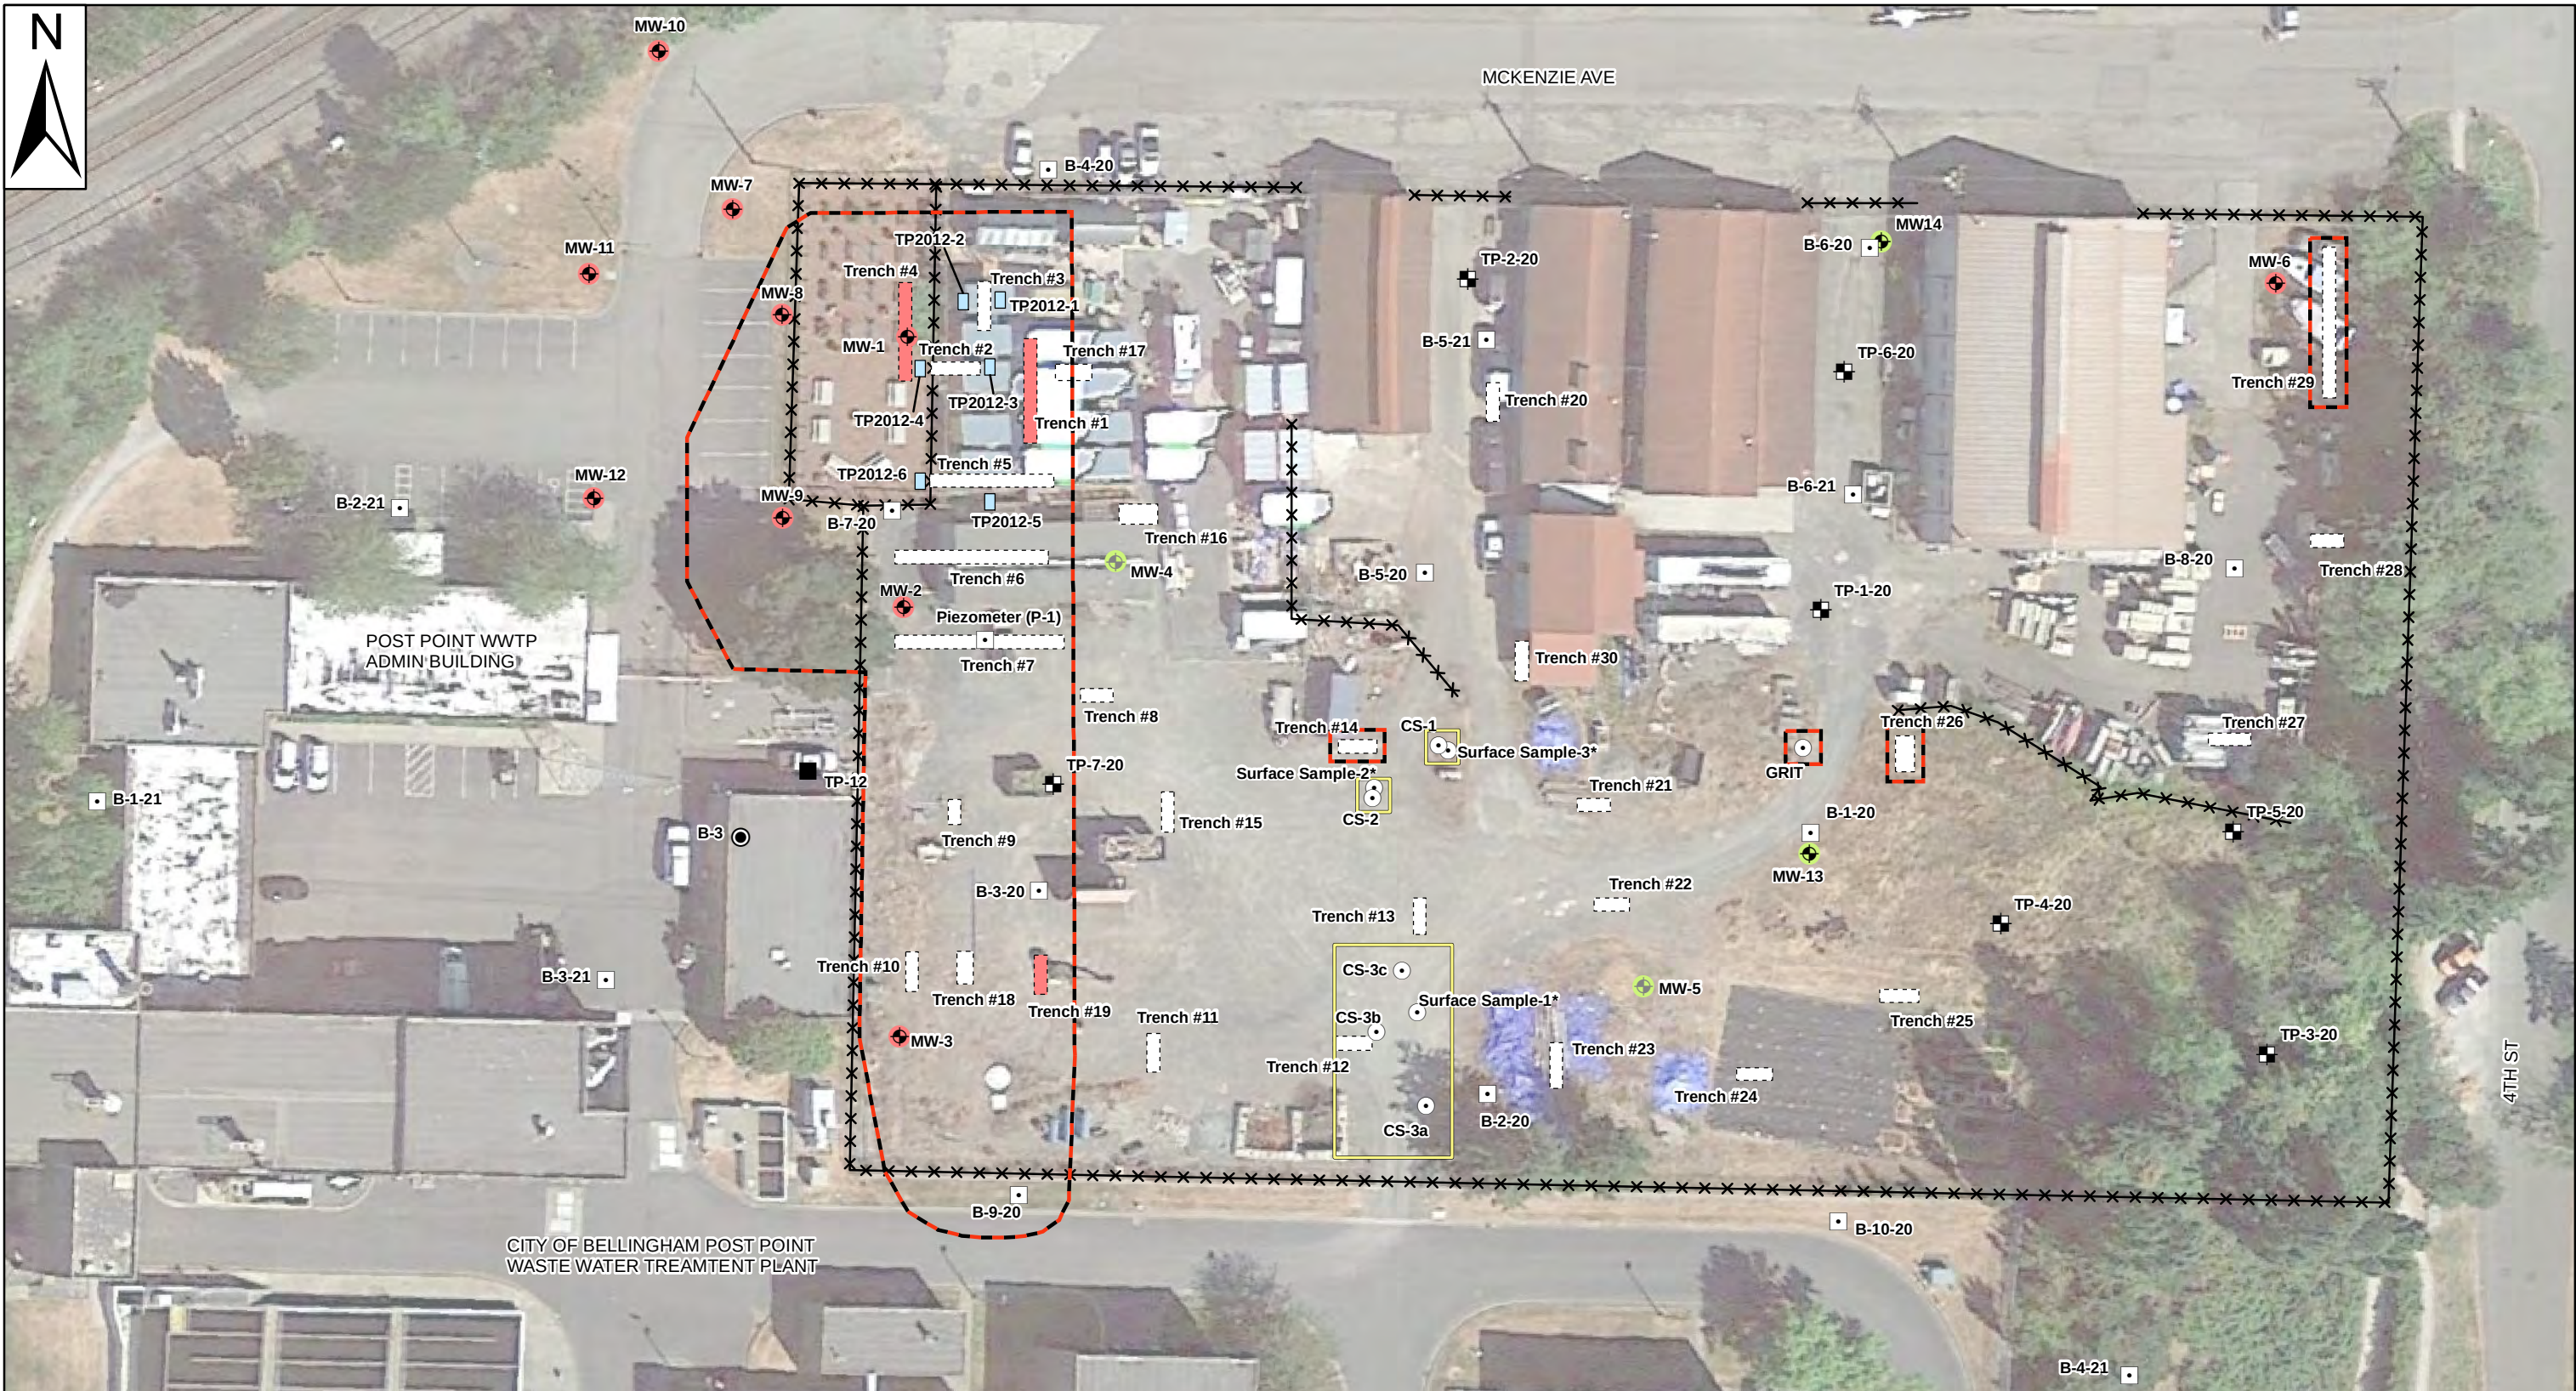
| <ul style="list-style-type: none"> <li>1989 Soil Borings</li> <li>1989 Test Pit</li> <li>2007 Surface Soil Sample</li> <li>2020 Test Pit Locations</li> </ul> | <ul style="list-style-type: none"> <li>2020 Soil Boring Locations</li> <li>Existing Monitoring Well</li> <li>Inaccessible Monitoring Well</li> <li>Result Exceeded CUL</li> <li>Result Met CUL</li> </ul> | <ul style="list-style-type: none"> <li>Surface Remedial Excavations</li> <li>2007 Test Trenches</li> <li>2012 Test Pit Locations</li> <li>Remaining Impacted Areas (Soil)</li> <li>Fenceline</li> </ul> | <p>All data are approximate and should be used for relative location reference only.</p> <p>2020 aerial photograph (GoogleEarth).</p> | <p>Prepared for:</p> <p> City of Bellingham</p> | <p>Prepared by:</p> <p></p> | <p>0 25 50 75 Feet</p> <p>1 inch = 50 feet</p> | <p>Historical Groundwater Sample Analytical Results Summary Map</p> <p>210 McKenzie Avenue<br/>Bellingham, WA 98225</p> |

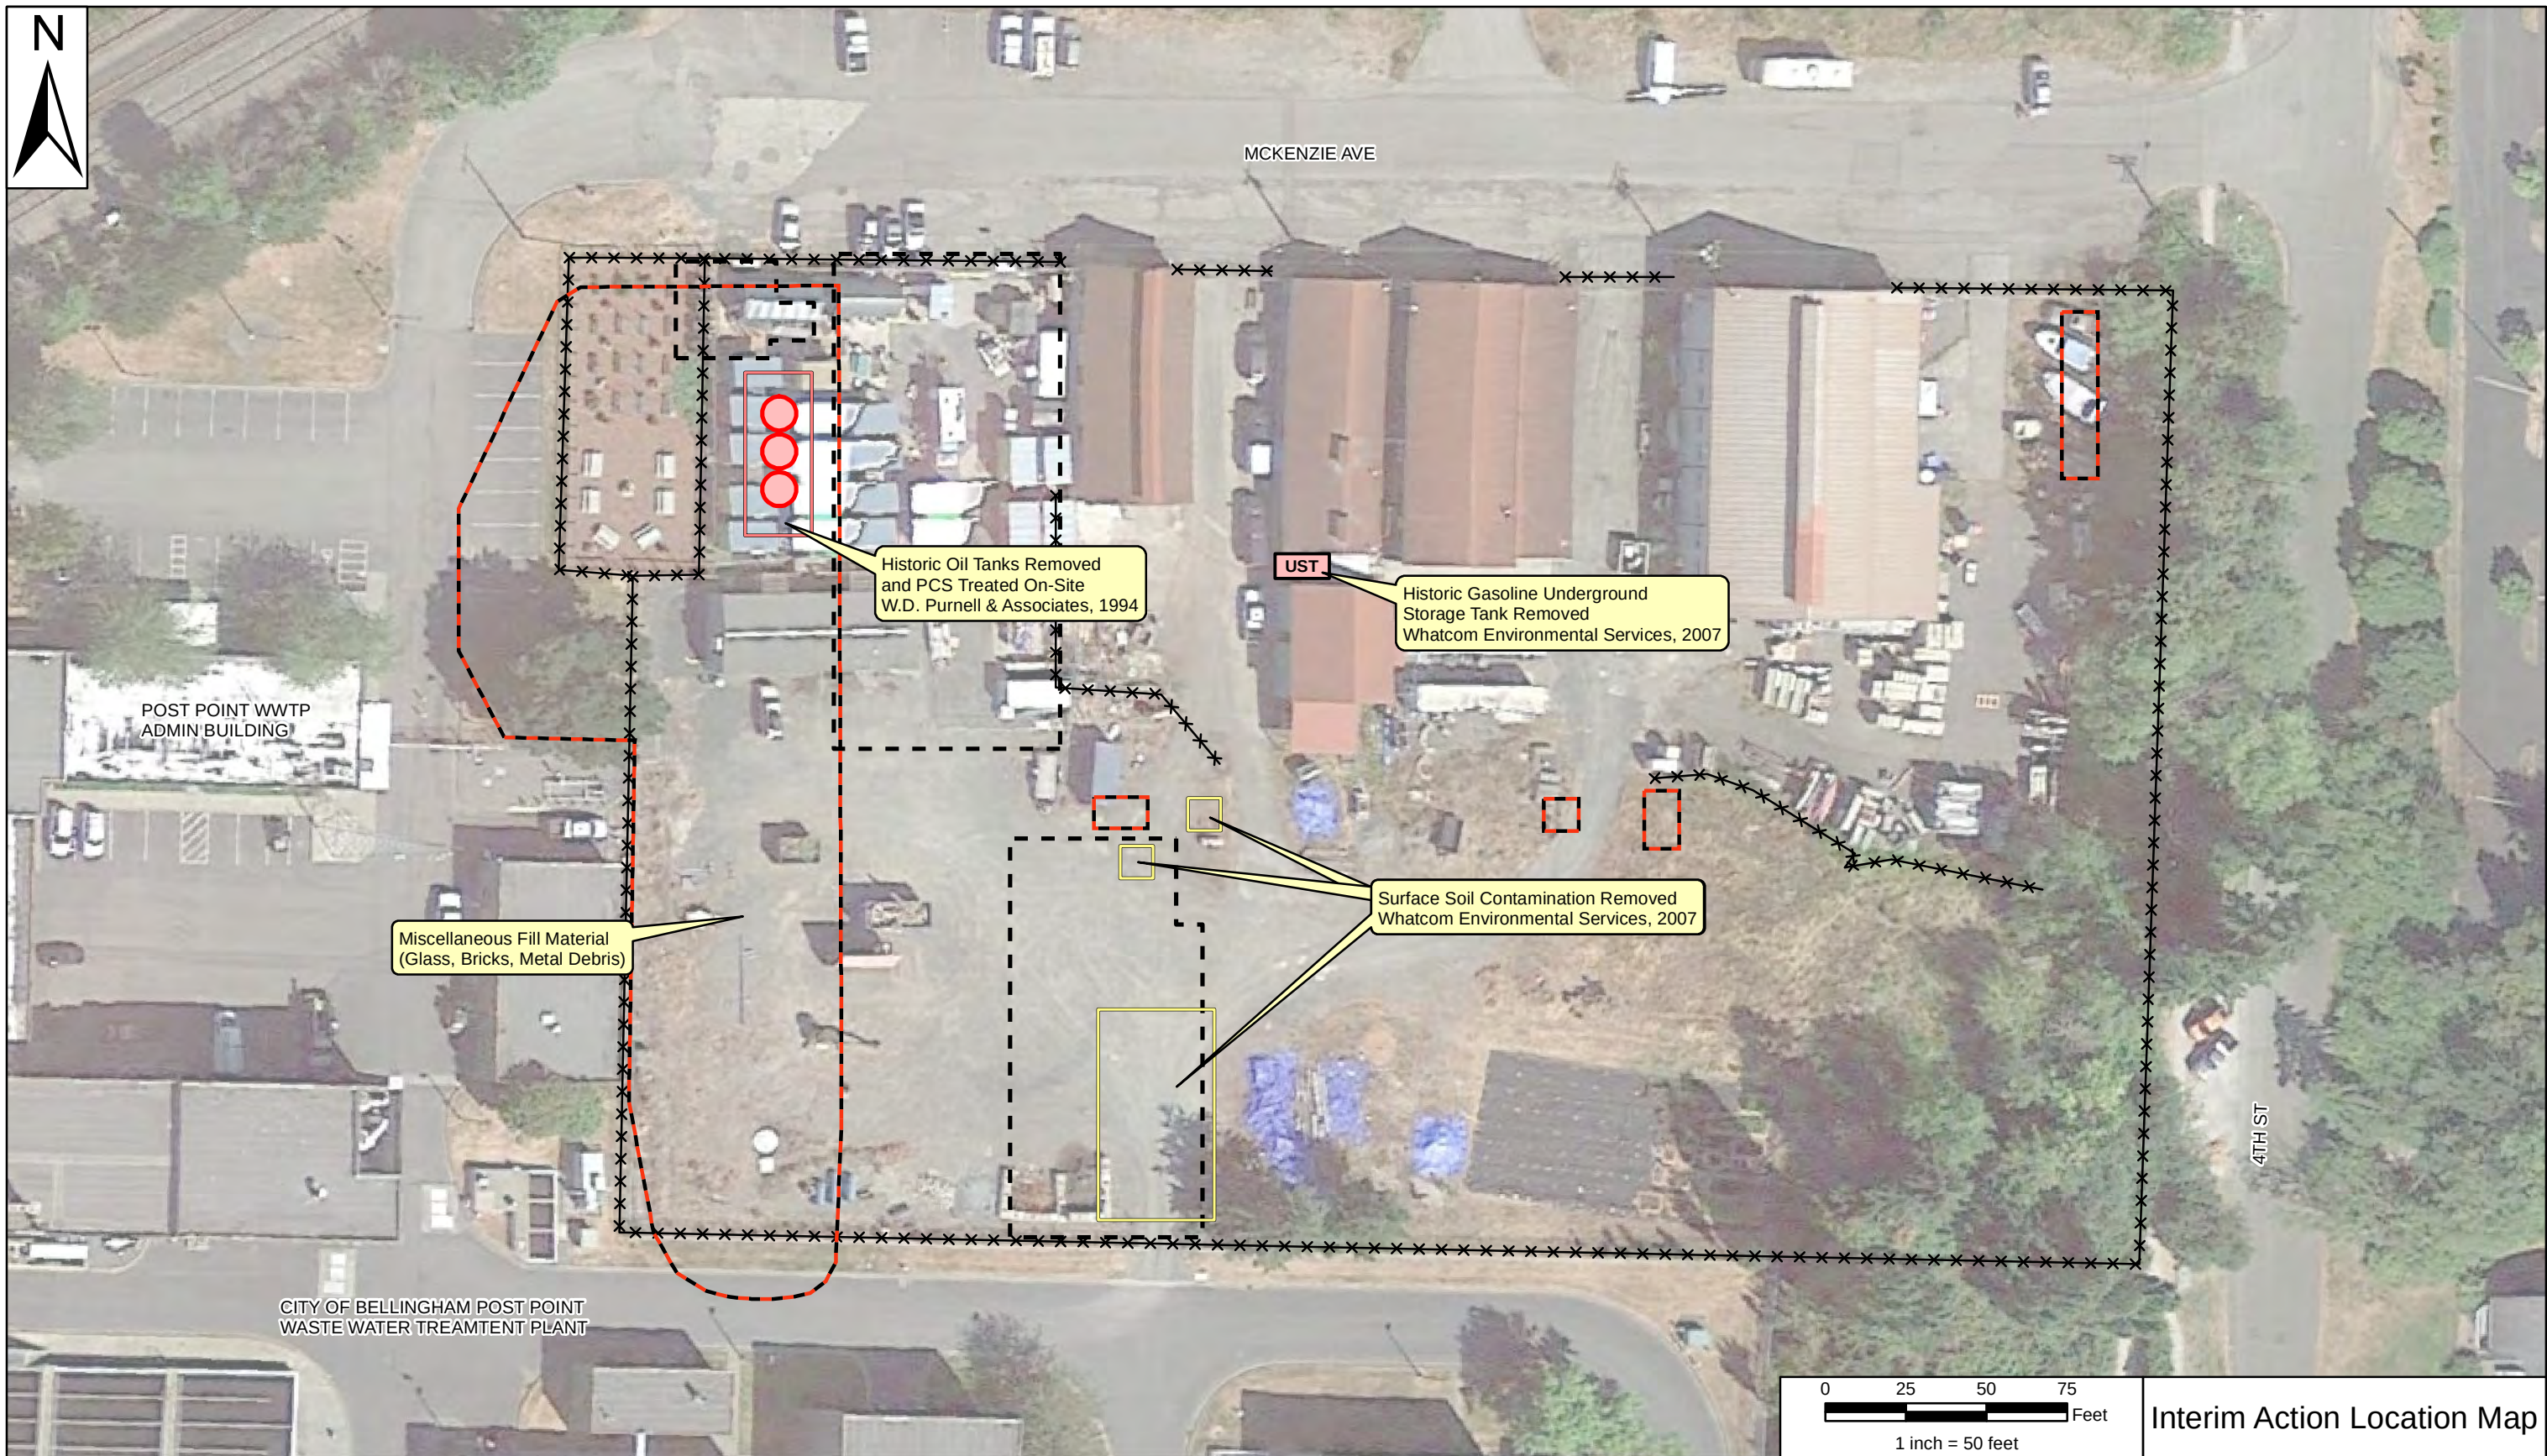
| 210 McKenzie Ave<br>02/26/24 | <b>Figure A-7</b> |

Interim Action Location Map
